**AN EVALUATION OF FIVE YEARS OF LOGGING RECOMMENDATIONS
FOR AQUATIC HABITAT PROTECTION ON THE QUINULT INDIAN RESERVATION**

**By
Daniel C. Fender
and
Stephen J. Dilley**

JANUARY, 1979

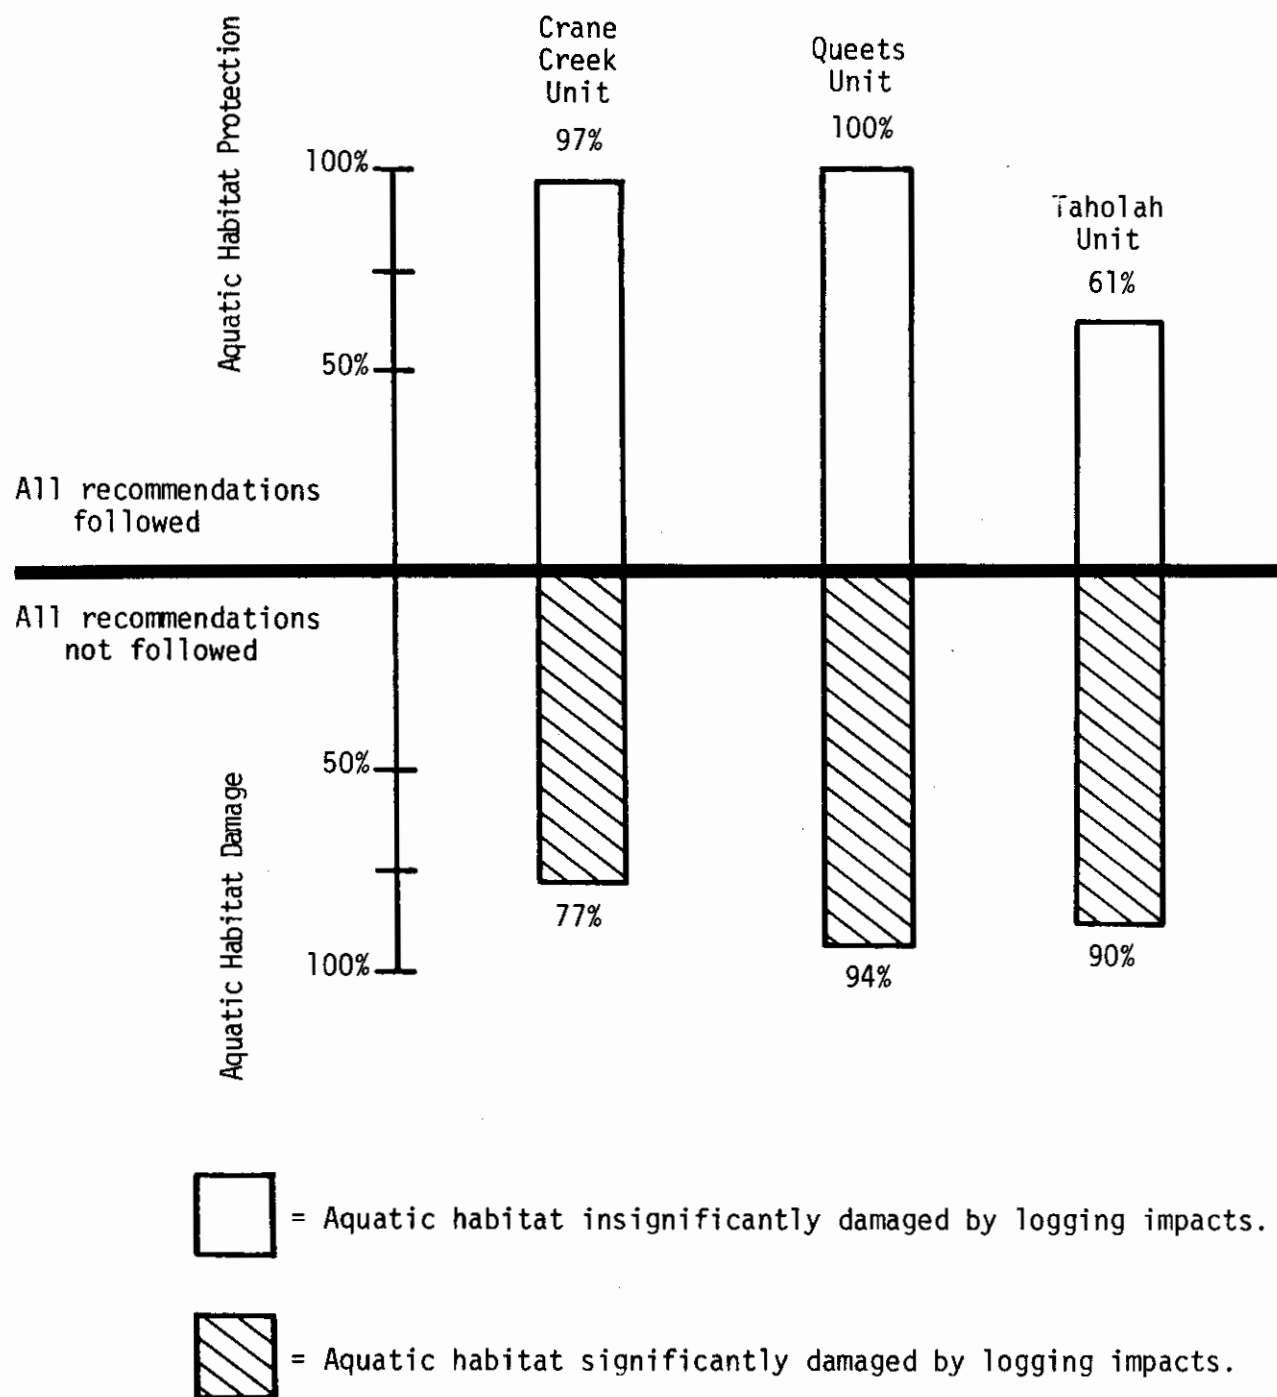
Figure 4: A summary of the relationships between complete adherence and non-adherence to logging recommendations and the resultant effect on the aquatic habitat.

The initial evaluation of the field data was aimed at determining the relationship between our logging recommendations and aquatic habitat protection. Figure 4 shows the results -- when all cases in which all recommendations were followed (89) were compared to those cases where all recommendations were not followed (73), we found a high correlation between adherence to our recommendations and aquatic habitat protection. As shown, in all the management units, when recommendations were completely followed the logging impact was evaluated to be moderate, with from 61% (Taholah) to 100% (Queets) of the associated habitat protected from logging. Yet in the same units, when similar recommendations were all not followed, the logging impact caused from 77% (Crane Creek) to 94% (Queets) damage to the associated aquatic habitat.

The information summarized in Figure 4 was obtained from the data on Table 2. This Table is shown here to reveal that in some cases, although our recommendations were used, the logging impact was not mitigated. As an example, in the Crane Creek unit there were eleven cases of complete adherence to recommendations for protection of streambanks; however, in one case significant damage resulted. Such unexpected relationships exist in both adherence and non-adherence evaluations. There were 22 (14%) of the 162 cases analyzed (90% of all possibilities) in which the relationship between adherence and non-adherence to specific recommendations and the resultant habitat quality were ambiguous (Table 3). These ambiguous cases were further investigated to determine strengths or weaknesses of our recommendations. The results reveal that 13 of these peculiar cases were attributed to inadequate recommendations, and 6 to inconclusive field observations. The balance were unique situations and were omitted in this evaluation. Notice that 11 of the 13 cases of inadequate recommendations were in the Taholah unit.

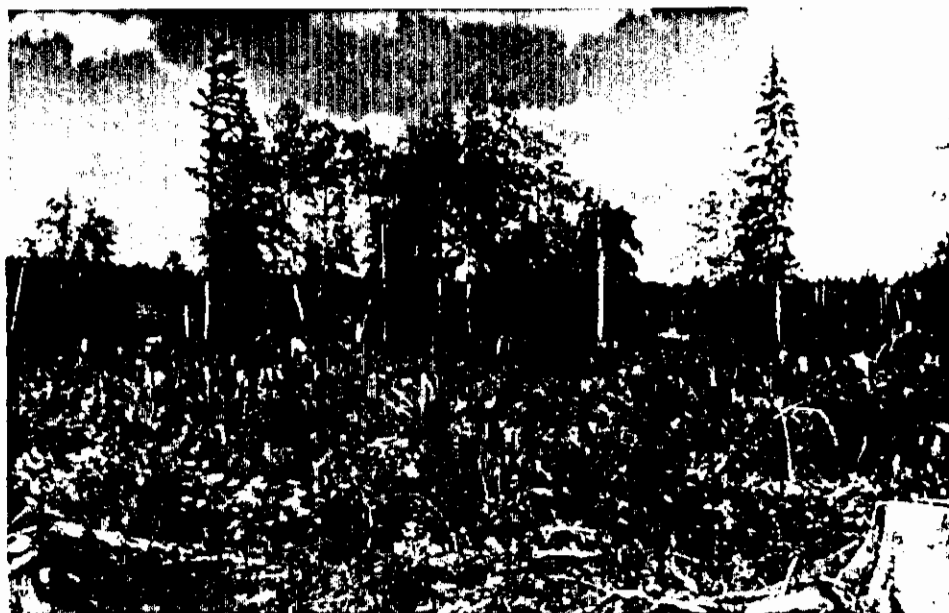
Crane Creek Unit, Block 300
Sec. 36, T23N, R11W.
Date Inspected: 8/28/78

Boulder Creek, a major tributary of the Quinault River, forms the north-west boundary of the block (see map). This creek averages 8 feet wide with a flow of about 3 cfs on the date inspected. Non-merchantable timber, hardwoods, herbaceous plants, and a dense growth of salmonberry lines the banks (Photos 1 & 2). No point source of silt was evident, but minor, apparently natural, bank erosion was noted. Minimal siltation of streambed gravel was observed (Photo 3). Very little logging-associated slash or debris was observed in the stream. However, slash was present at the high water mark, but was immobilized by the dense streamside vegetation. No logjams, bridges, or culverts were present on this stream.

Photo 1. Buffer strip of non-merchantable timber remaining on bank of Boulder Creek.

Our recommendations were closely adhered to, and the aquatic habitat was evaluated to have been protected from adverse logging impacts. The flat topography and timber species in this block were probably beneficial factors contributing to the desirable results observed. The most important factor contributing to the protection of the aquatic habitat in this block, however, is the preservation of the partial buffer strip during logging (Photo 1). This prevented destruction of banks, streamside vegetation and blocked logging debris from entering the stream.
